# Manhole Inspection Summary

Manhole # S25AA\_019MH

Insp Date: **9/13/07 8:52 AM**

**Location** Address: **814 CAREY ST**

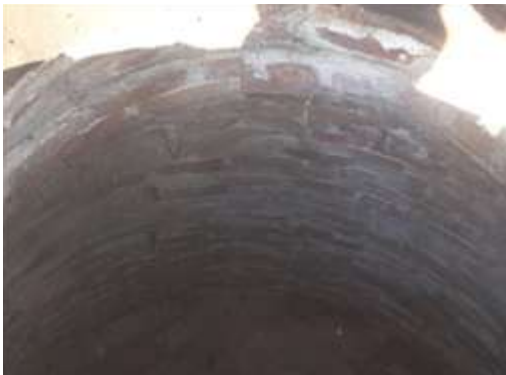
Defect 3

Count: **0** Missing: **5** ☐ Corroded

ALL STEPS MISSING

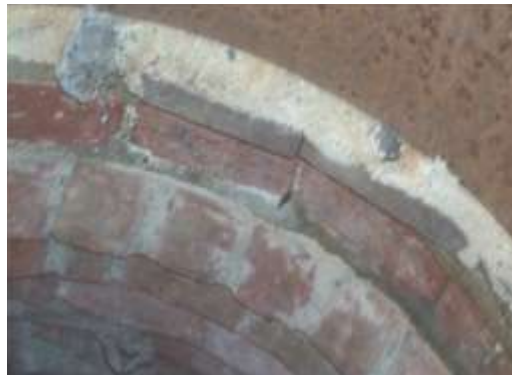
Defect 2

Condition: ☐ Sound ☒ **Cracked** ☐ Root Intrusion ☒ **Loose Brick** ☐ Deteriorated

LOOSE CHIMNEY

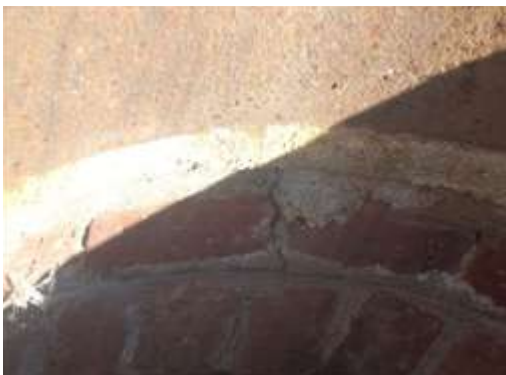
Defect 1

CRACKED CHIMNEY

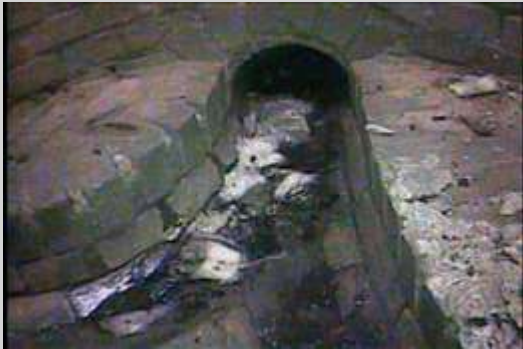
12 O'Clock Outflow

Pipe Height: **8.4** (in.) Rod and Bar (Angled)  
Pipe Material: **Clay** ☐ Pipe Lined  
Invert Depth: **8.69** (ft.) Flow Characteristics: **Slow**  
Deposits: ☐ None ☐ Mud ☒ **Sludge** ☐ Debris ☐ Grease  
Silt Depth: **3** (in.) Deposits Extent: **Medium**  
Infiltration: **None** Pipe Seal Cond: **Sound**
